# Repairs on Controllable Pitch Propeller

## History

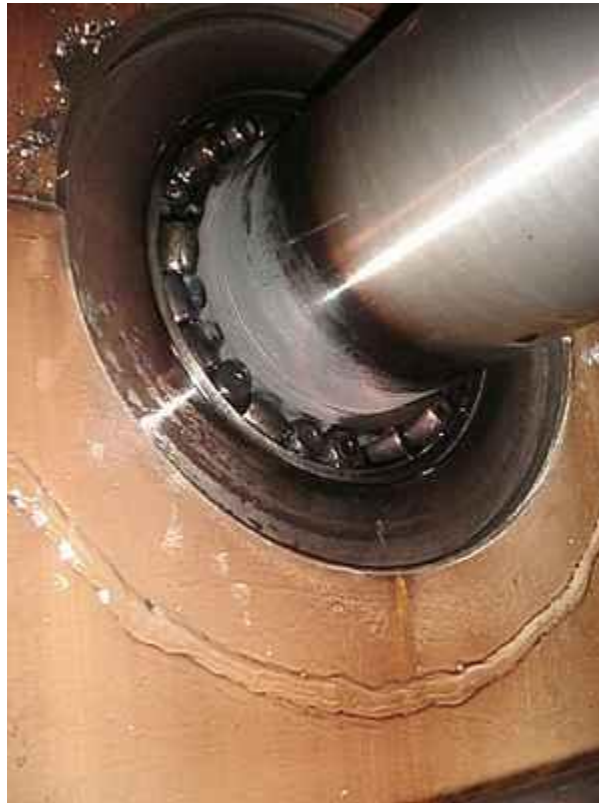
Damage was noted to the non-controllable PTO shaft. The centre bearing had failed due to unknown cause. The cage had disintegrated and allowing the rollers to move axially. Several rollers had turned through 90° and begun to slide. Overheating led to a contained explosion of the oil mist.

One off roller exited the damaged bearing and entered the main gear mesh. The roller had fell into the trough of the controllable pinion and then pressed into the metal. The Bull wheel teeth was then damaged by contact with this roller. The damage to the bull wheel teeth caused a deformation and spreading at the root. The reduced backlash then led to interference damage on the teeth of the pinion. Removing the non controllable pinion shaft indicated a badly worn bearing housing.

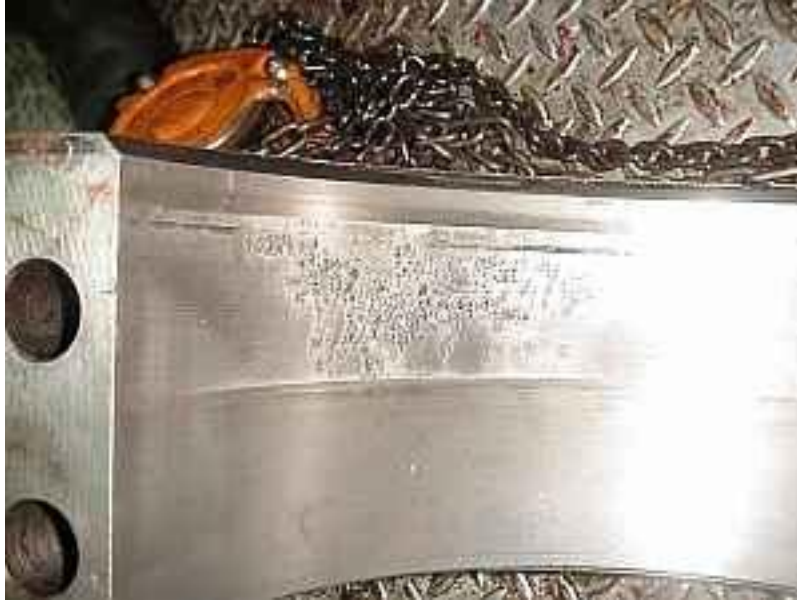
This was the most likely source of failures. Oil galleries, flexible couplings were inspected. Recent Lube Oil analysis had not indicated any fault

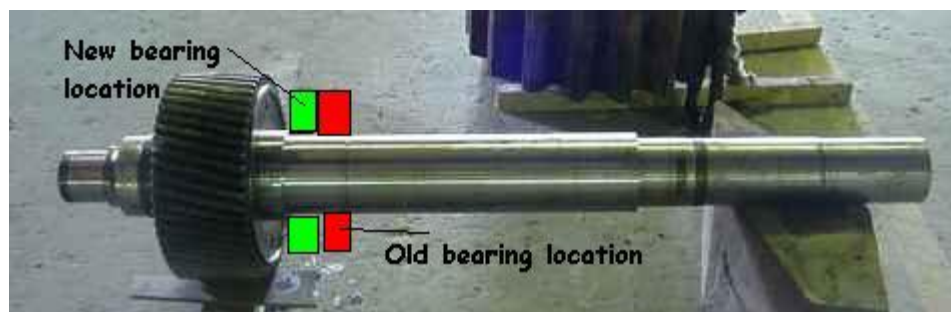
The non-controllable PTO shaft was removed and a new shaft supplied. The damage to the bearing keep was such that there was excessive clearance to the bearing. Line boring was not an option with the facilities available at the shipyard. The time to bring in suitable outside contractors would have incurred excessive off hire costs.

With manufacturer agreement the shaft was machined to move the bearing location to the good portion of the keep. As the shaft is non-controllable it requires no clutch. Therefore the loading on the centre bearing is reduced and a smaller width bearing used which utilises half the keep landing area.

A spacer was fitted in place of the old bearing to allow reuse of the original circlip groove.

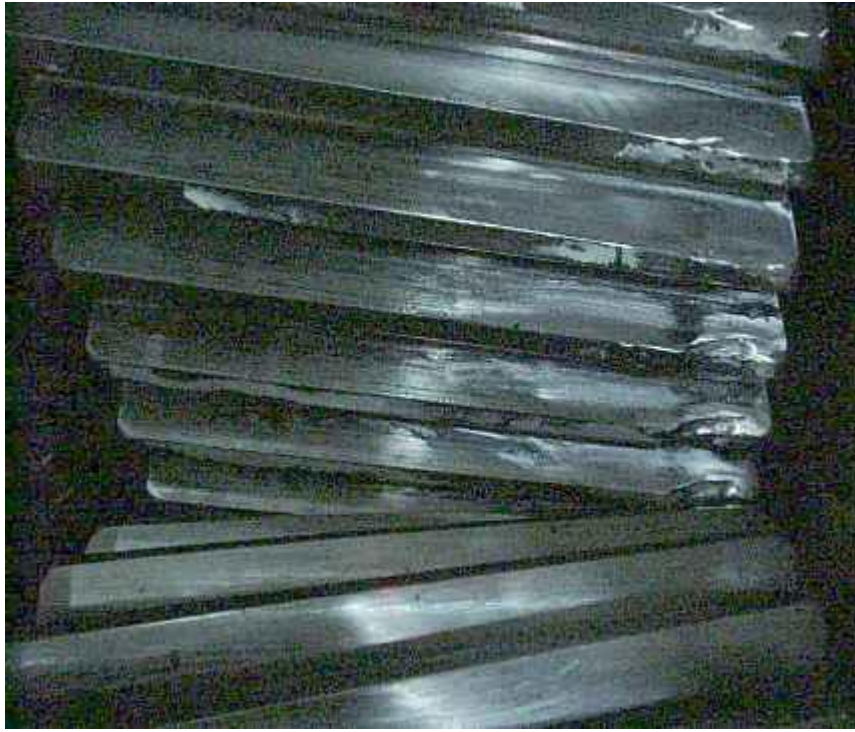
The entire bull wheel and pinion teeth mesh was magnafluxed. Two small cracks were detected where the roller had been pressed in. These were ground out completely.

The bull wheel and pinions were ground using angle grinders and fine sandpaper pads. Blue was used to ensure that there was no contact in the damaged area and sufficient backlash existed.

The system was flushed with hydraulic oil to clean and then refilled. The system was run at 15% load for one week and then steadily increased to 35% over the next month. Magnaflux was repeated and any asperities indicated by local spalling ground out.
